Field Testing and Summary Report for Road 5 (Morris Road) Over Road 3 (Toftoy Throughway) at Redstone Arsenal, AL

Contractor's Supplemental Report for Project F09-AR16

**FIELD TESTING AND SUMMARY REPORT:
ROAD 5 (MORRIS RD) OVER ROAD 3 (TOFTOY
THWY) REDSTONE ARSENAL, AL**

April, 2010

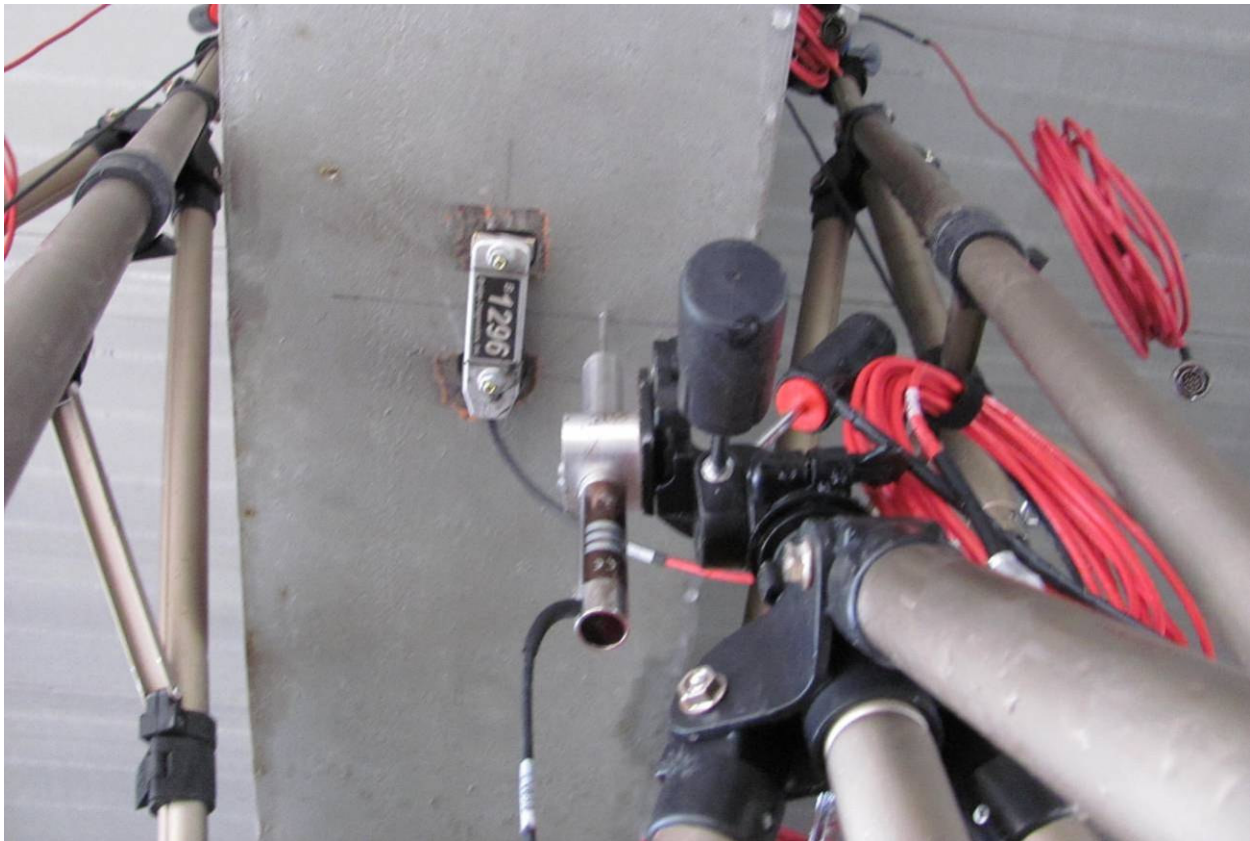
Figure 1.1 Typical strain gage and LVDT on bottom of beam.

The superstructure (beams and deck) was instrumented with 14 strain transducers and 9 Linear Varying Differential Transformer (LVDT) displacement sensors, as shown in Figure 1.1 through Figure 1.9. The intent of the instrumentation was to measure the deck strain and deflection relative to the steel girders. LVDT's were mounted to tri-pods, which in turn were placed on the concrete sloped apron of the abutment. Semi-static load tests were performed with a 3-axle dump truck (speed approximately 5 mph) at three lateral load positions. Strain measurements and truck position were recorded continuously at a sample rate of 40Hz as the test truck was driven across the bridge at crawl speed.

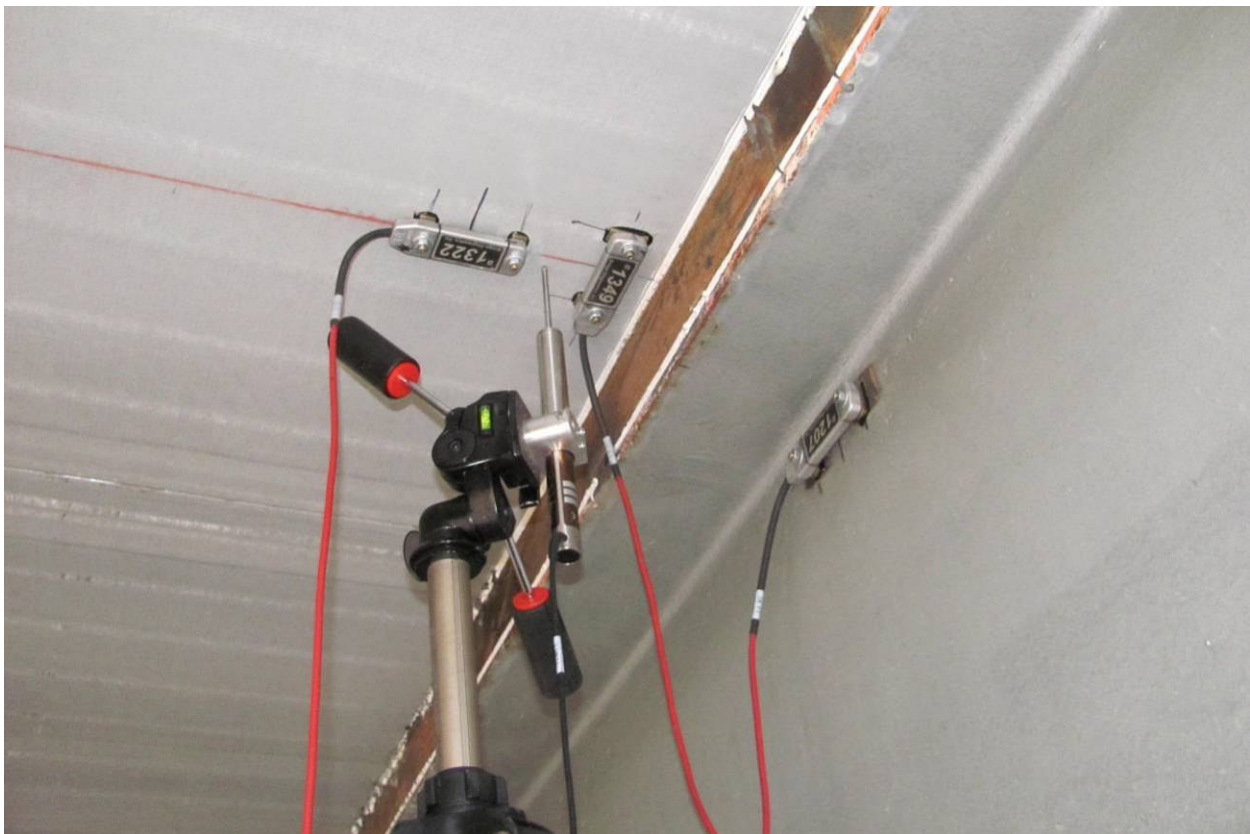
Figure 1.2 Typical strain gages and LVDT at top of beam and edge of FRP deck panel.

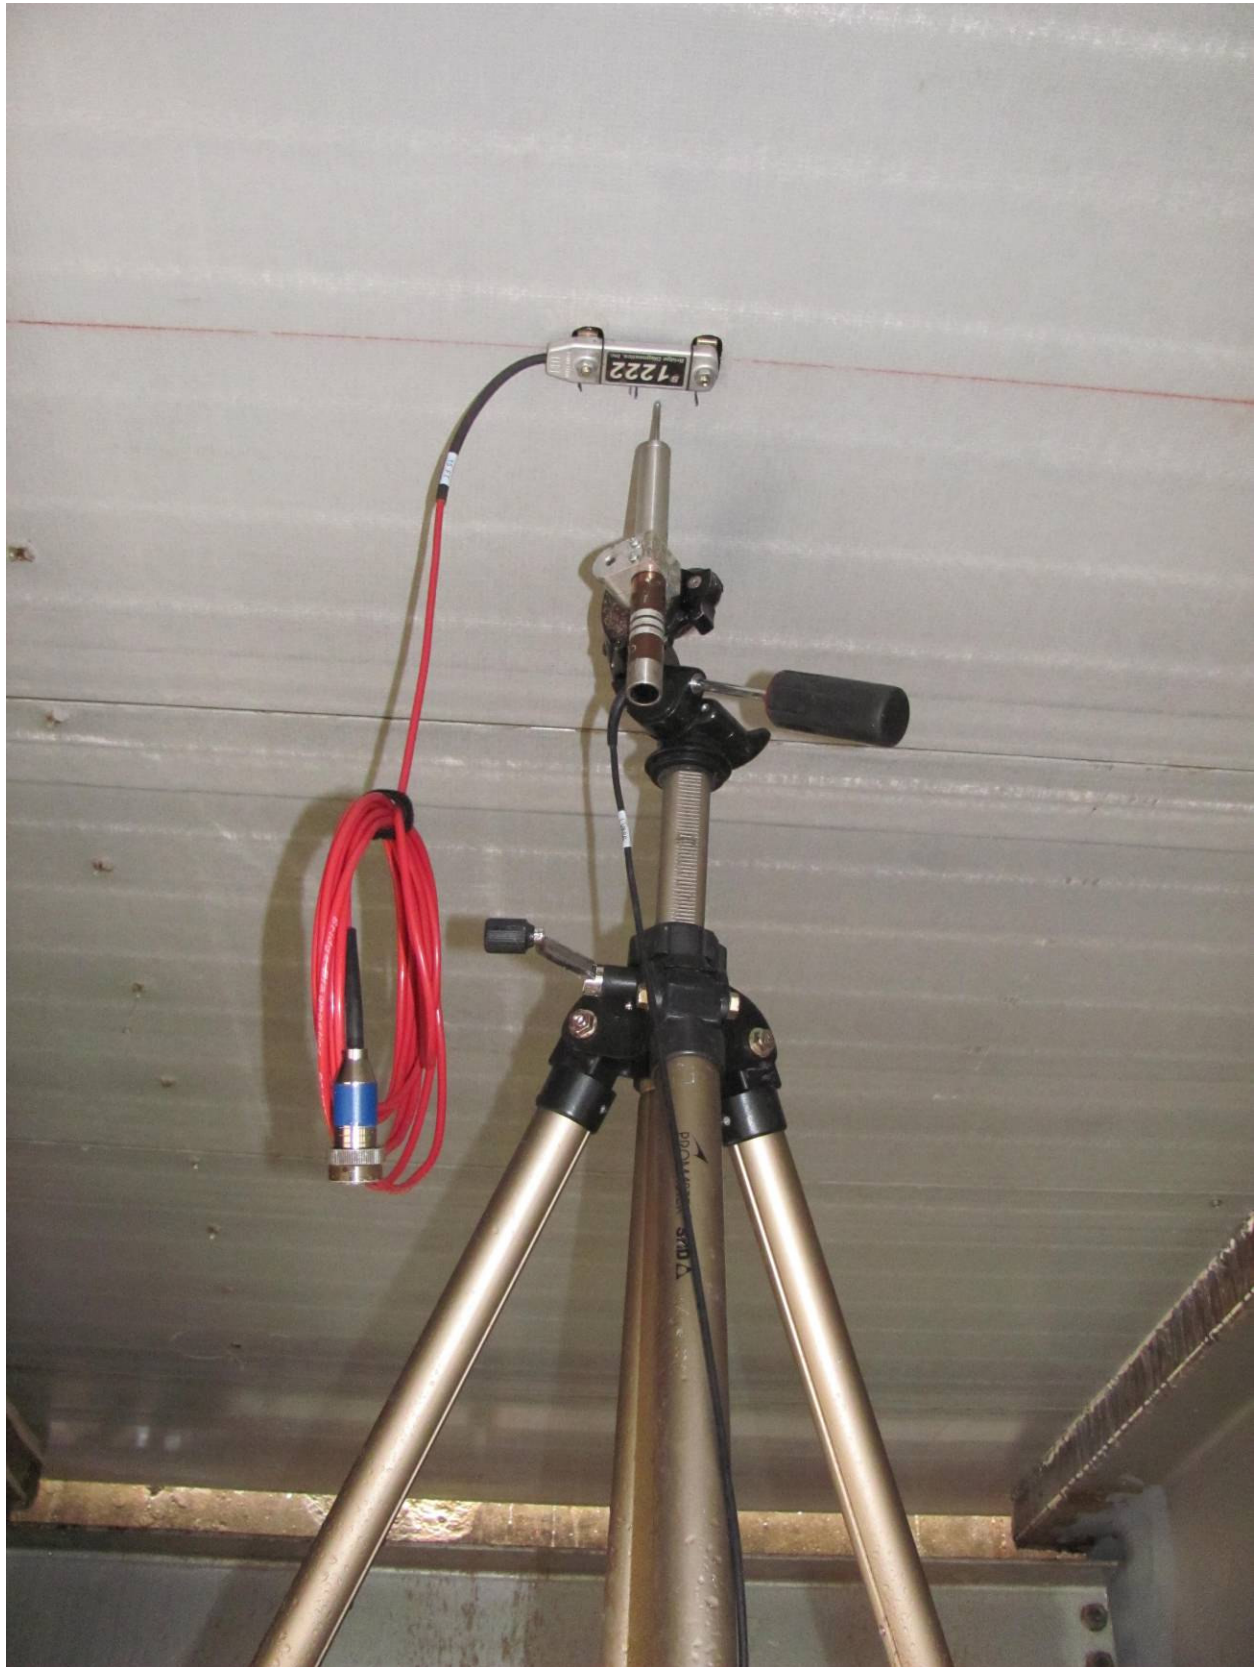
Figure 1.3 Typical strain gage and LVDT at midspan of FRP deck panel.

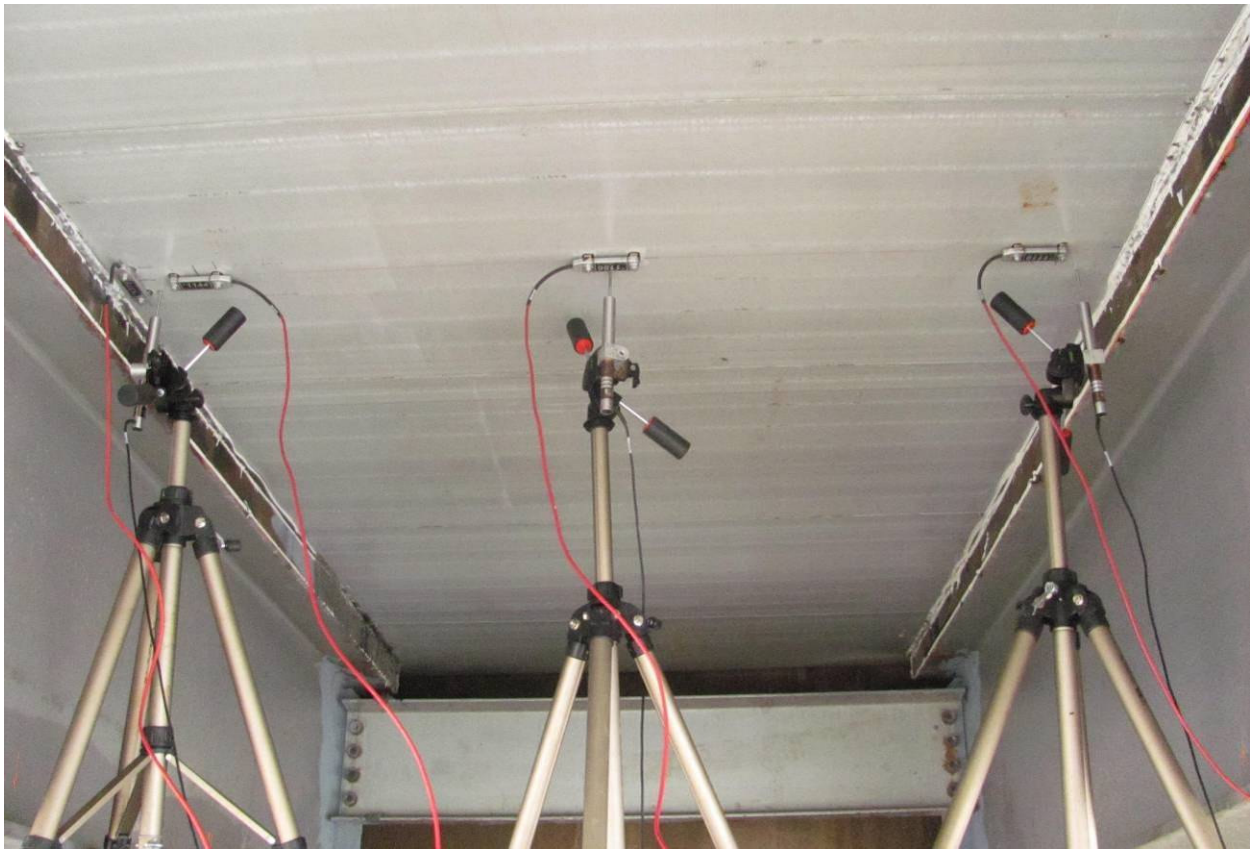
Figure 1.4 Typical FRP deck instrumentation between beams.

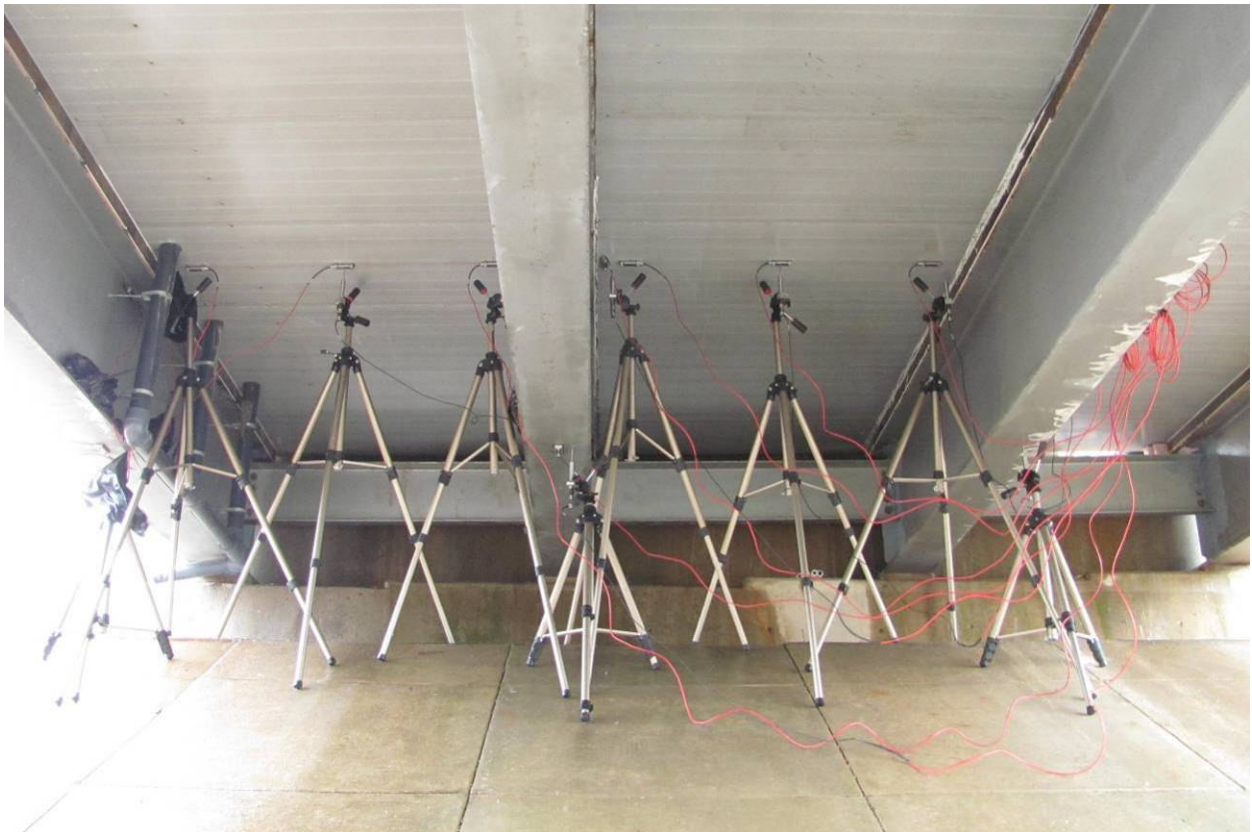
Figure 1.5 Overall view of entire instrumentation setup.

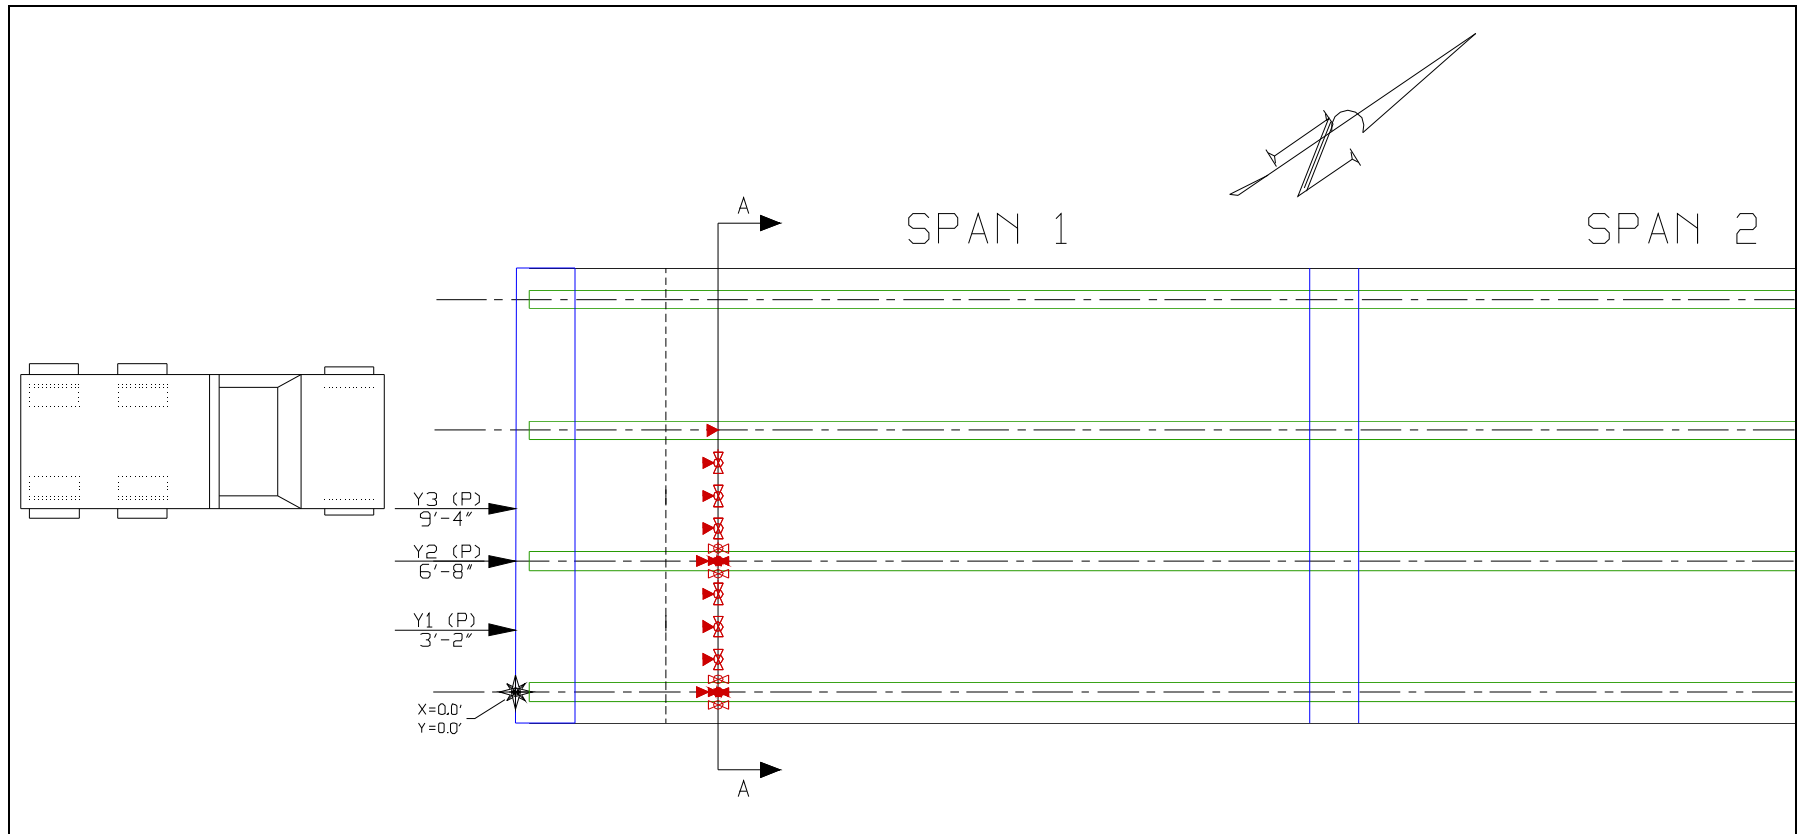
Figure 1.6 Instrumentation plan with truck positions and gage locations.

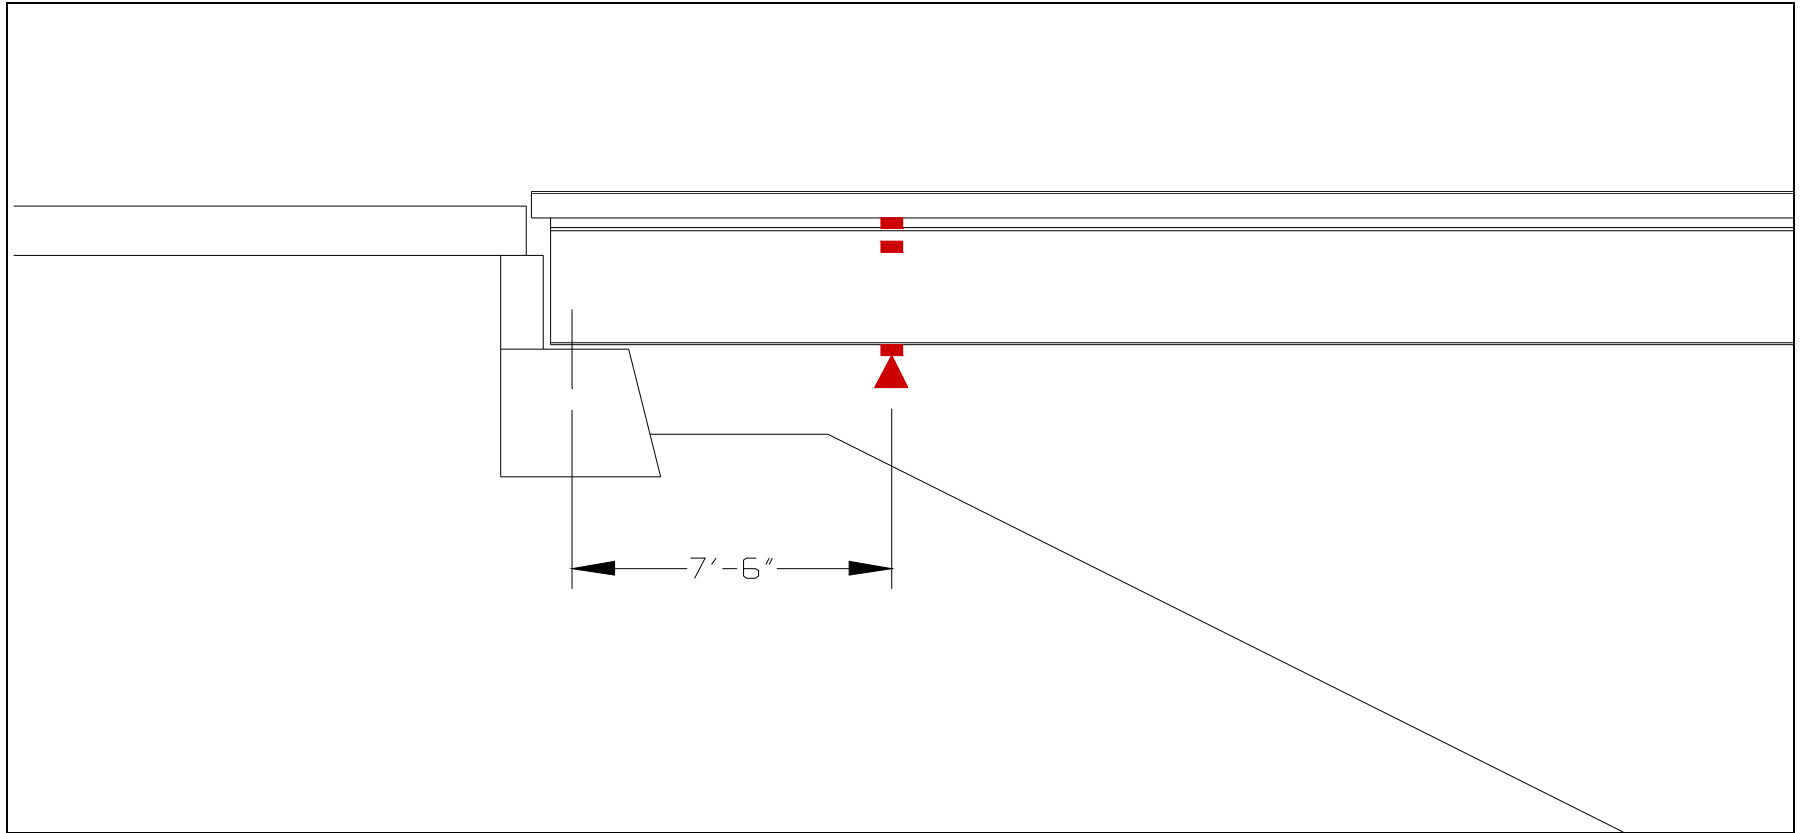
Figure 1.7 Elevation view with longitudinal gage locations.

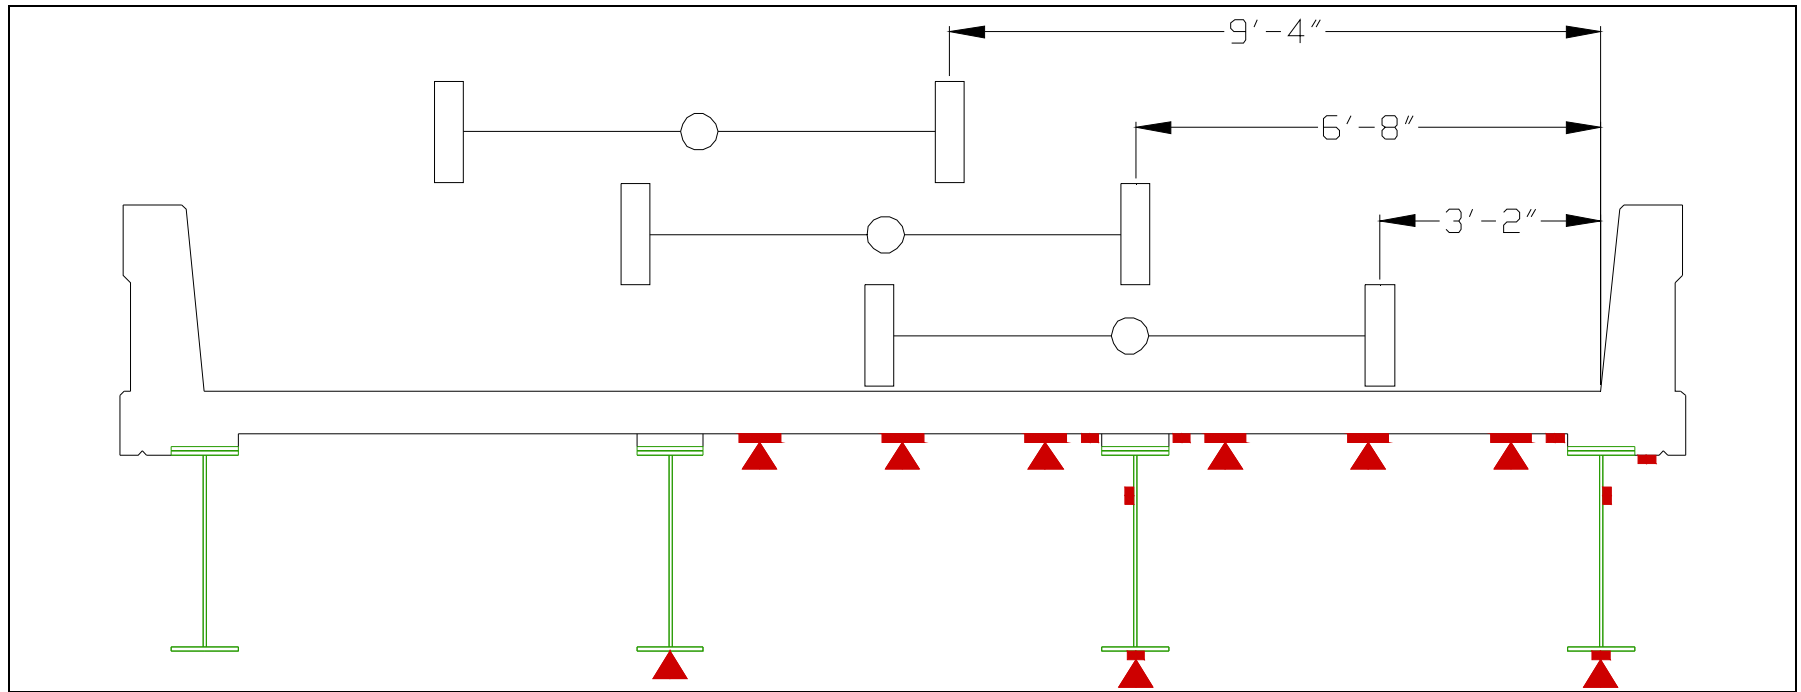
Figure 1.8 Cross-section with gage locations and truck positions.

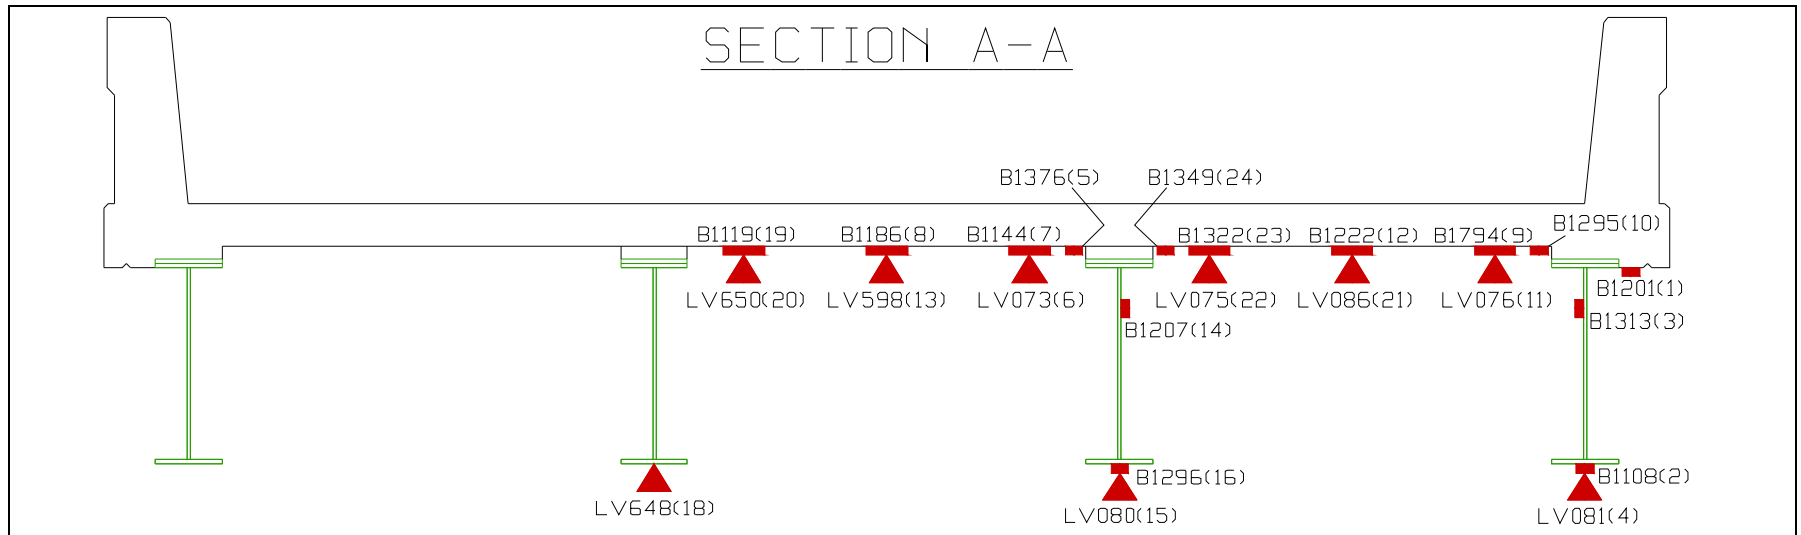
Figure 1.9 Cross-section with gage ID's.

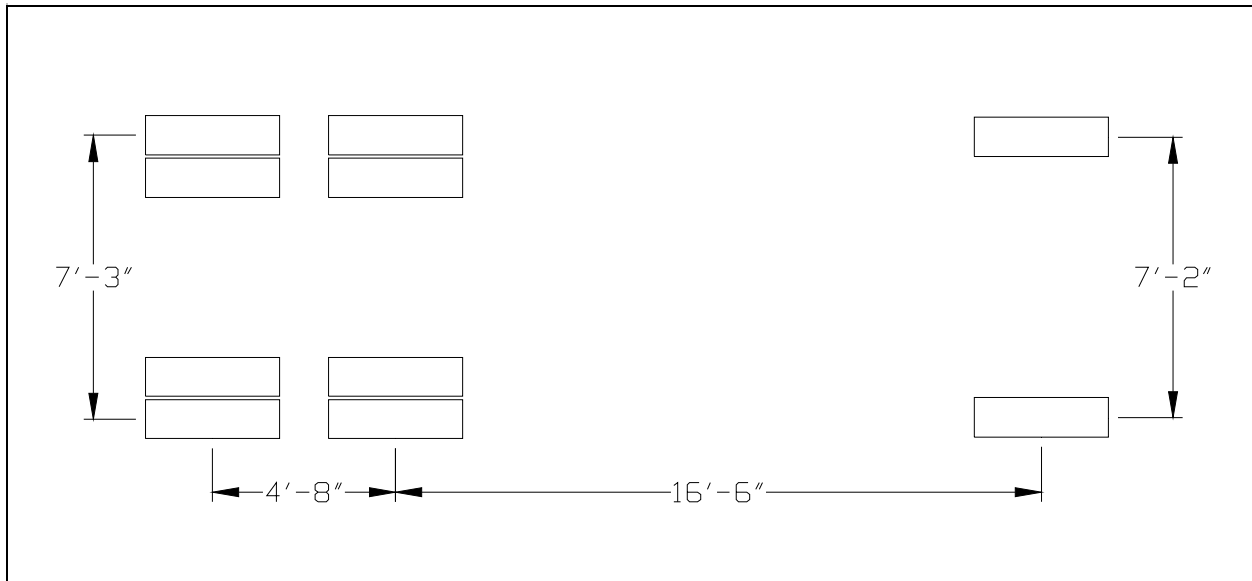
**Figure 1.10 Dump truck vehicle footprint.**

Information specific to this load test can be found in Table 1.1 and the field notes in Appendix B. The test vehicle's gross-weight and wheel rollout distance (required for tracking its position across the structure) are provided in Table 1.2. A "footprint" of the vehicle is also shown in Figure 1.10 for reference. The vehicle weight was obtained off-site and provided to BDI by Angelo Iafrate Construction and MEC.

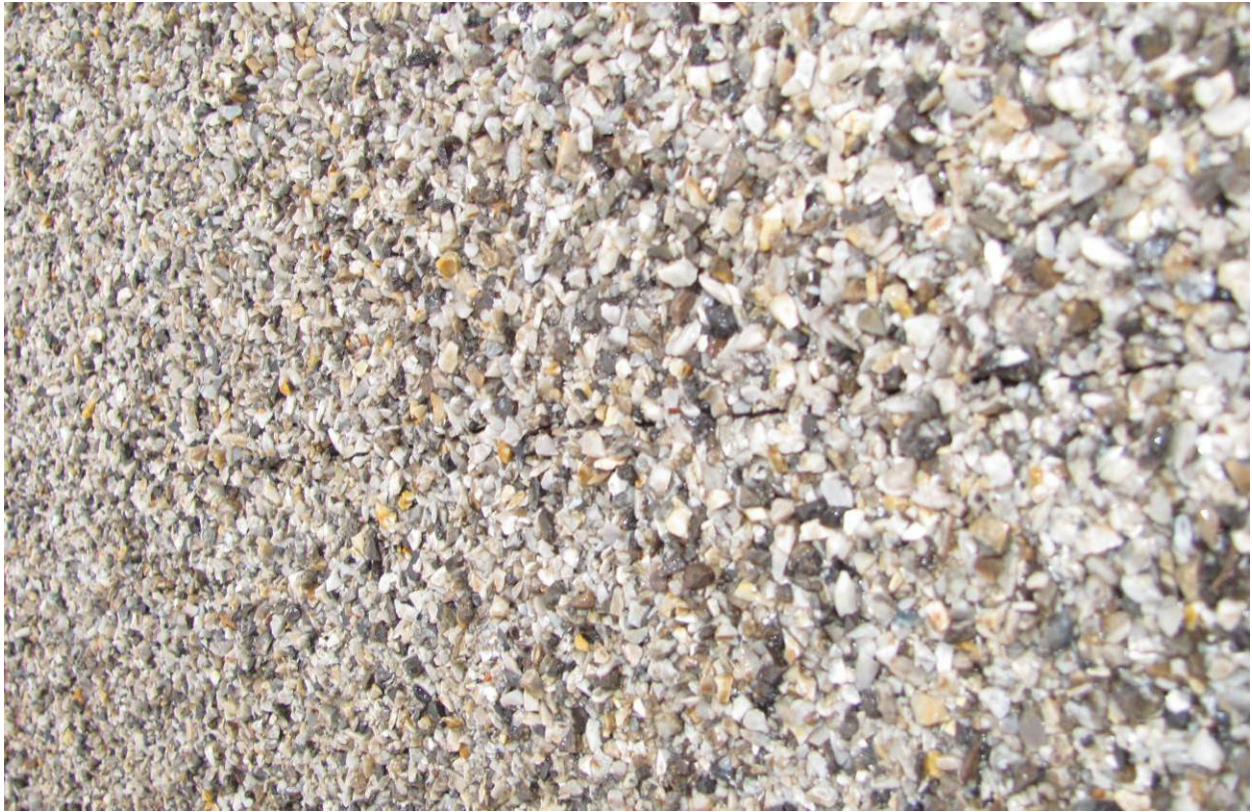
Figure 1.11 Longitudinal crack or seam observed in wearing surface.

Red_5.dat	Y2	Truck ~3"-4" east
	Red_6.dat	Y2	Good
	Red_7.dat	Y3	Good
	Red_8.dat	Y3	Truck ~6" west
	Red_9.dat	Y3	Good
COMMENTS	Fairly large, longitudinal crack or seam observed in the wearing surface – see Figure 1.11 and Figure 1.12

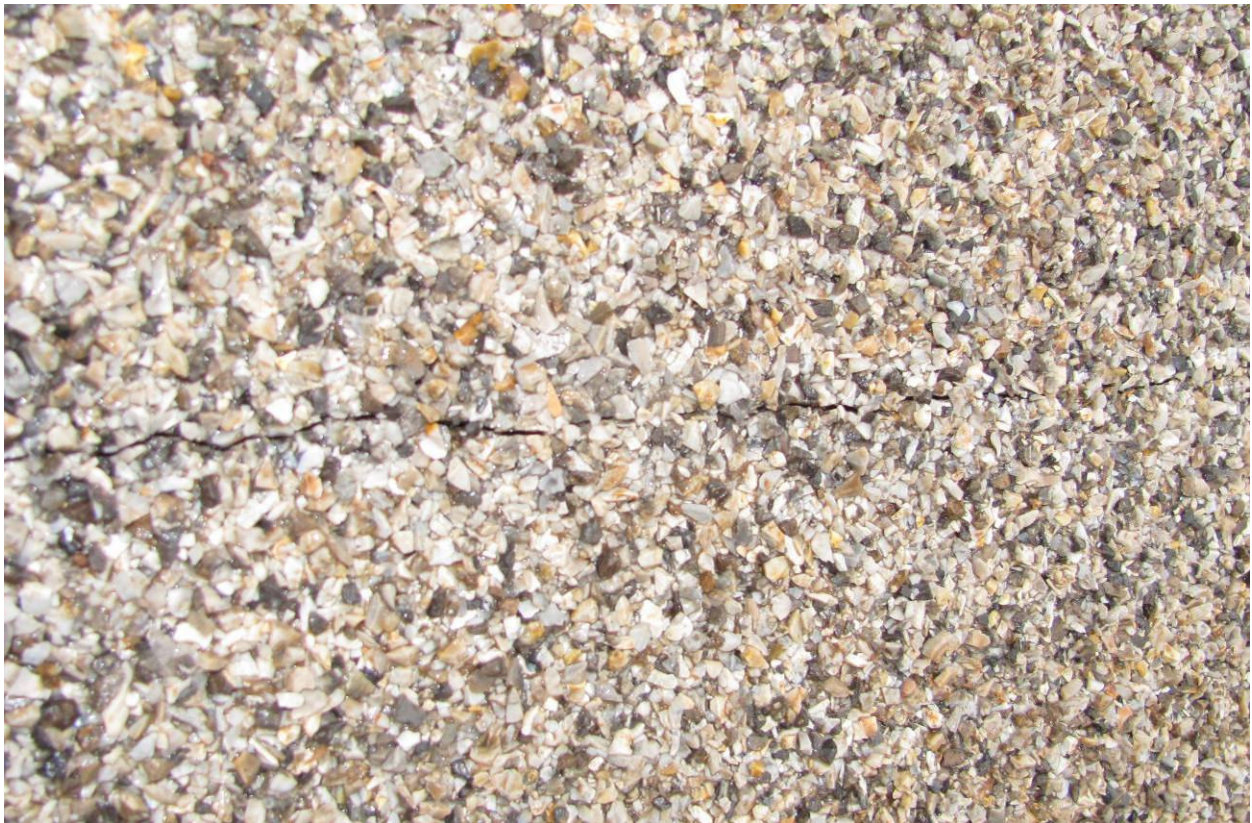
Figure 1.12 Longitudinal crack or seam observed in wearing surface.

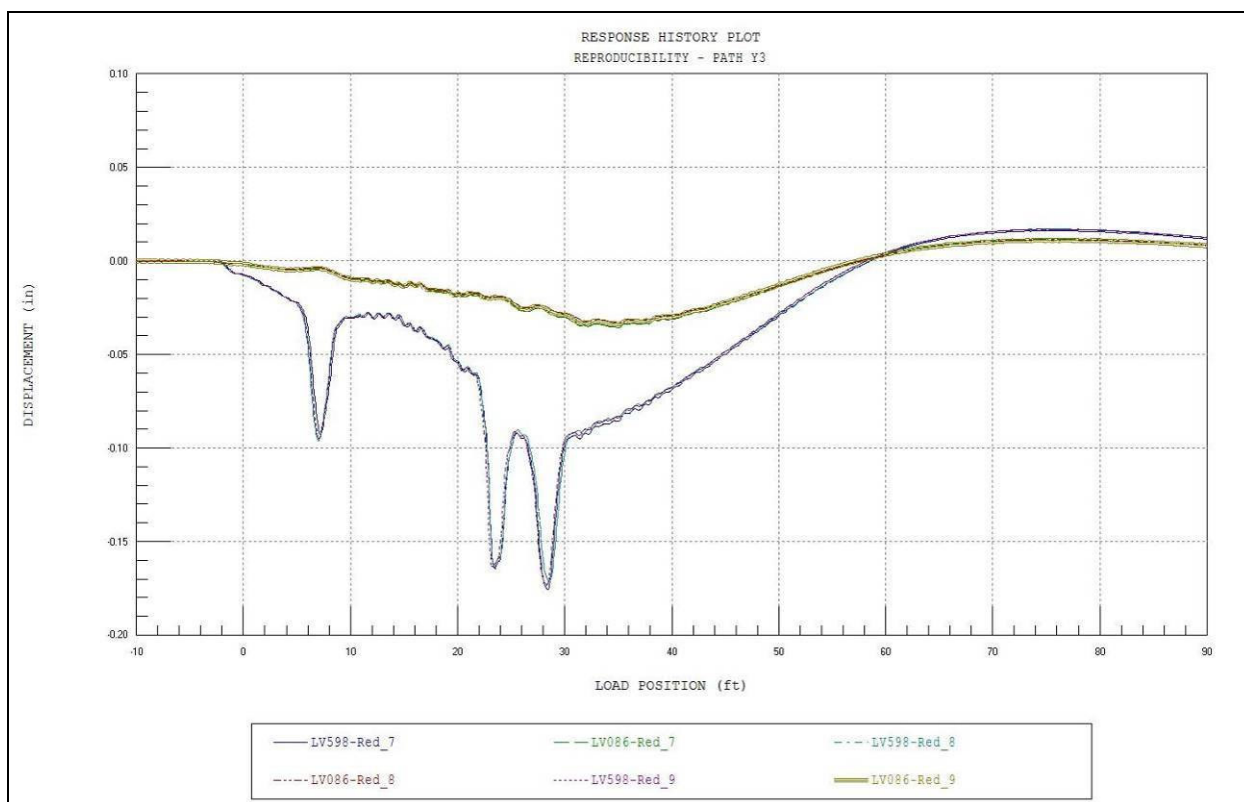
Figure 2.1 Reproducibility of deck displacement measurements – Path Y3.

- ***REPRODUCIBILITY AND LINEARITY:*** Responses from identical truck paths were very reproducible as shown in Figure 2.1. In addition, all strains and displacements appeared to be linear with respect to load magnitude (truck position). Note that responses did not return to zero, but this was a result of the beams being continuous over several spans and the test truck not being driven all the way off of the bridge. For all tests, the test truck was stopped near the end of Span 2, which resulted in the strain and displacement response histories displaying negative moment at the end of the tests. Figure 2.1 shows the response histories for midspan deck displacement gages in the middle bay and side bay for three identical truck paths along Path Y3. All of the response histories had a similar degree of reproducibility and linearity indicating that the data collected was of very good quality.

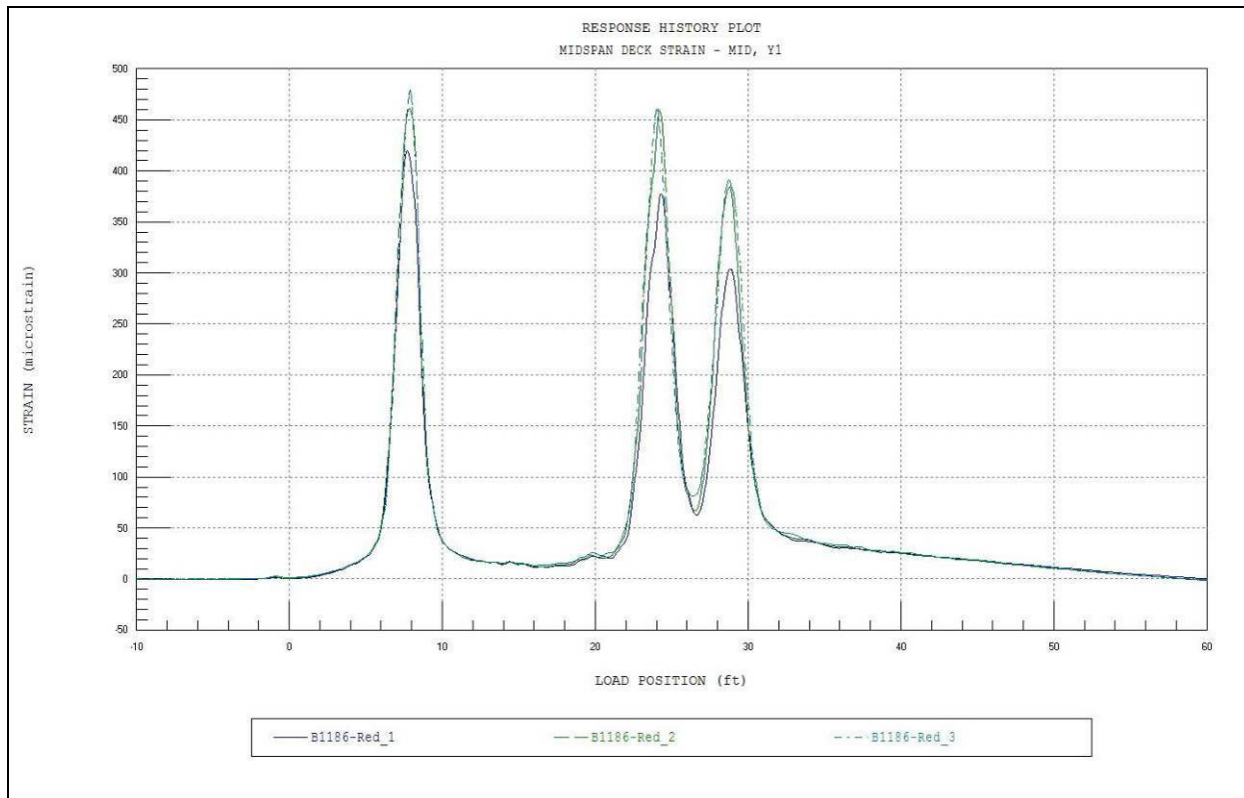
Figure 2.2 Deck strain measurements at interior bay for 3 truck passes along Path Y1.

- ***MIDSPAN FRP DECK STRAINS:*** Midspan, flexural deck strains were measured at two locations: in the middle bay directly centered between the two interior beams, and in one side bay directly centered between an interior beam and the corresponding exterior beam. Truck Paths Y1 and Y3 were located so as to generate maximum strains at these specific locations. In general, recorded maximum live load strains were in the range of 500-600 $\mu\epsilon$, which corresponds to about 550-700 $\mu\epsilon$ for HS-20 design loading (without impact). Figure 2.2 and Figure 2.3 show the flexural deck strains in the two previously described locations for truck Path Y1, while Figure 2.4 shows the deck strain in the middle bay generated by truck Path Y3. Note that deck strain responses are extremely sensitive to variations in lateral truck position, and therefore do not appear quite as reproducible as displacement responses for the same truck paths.

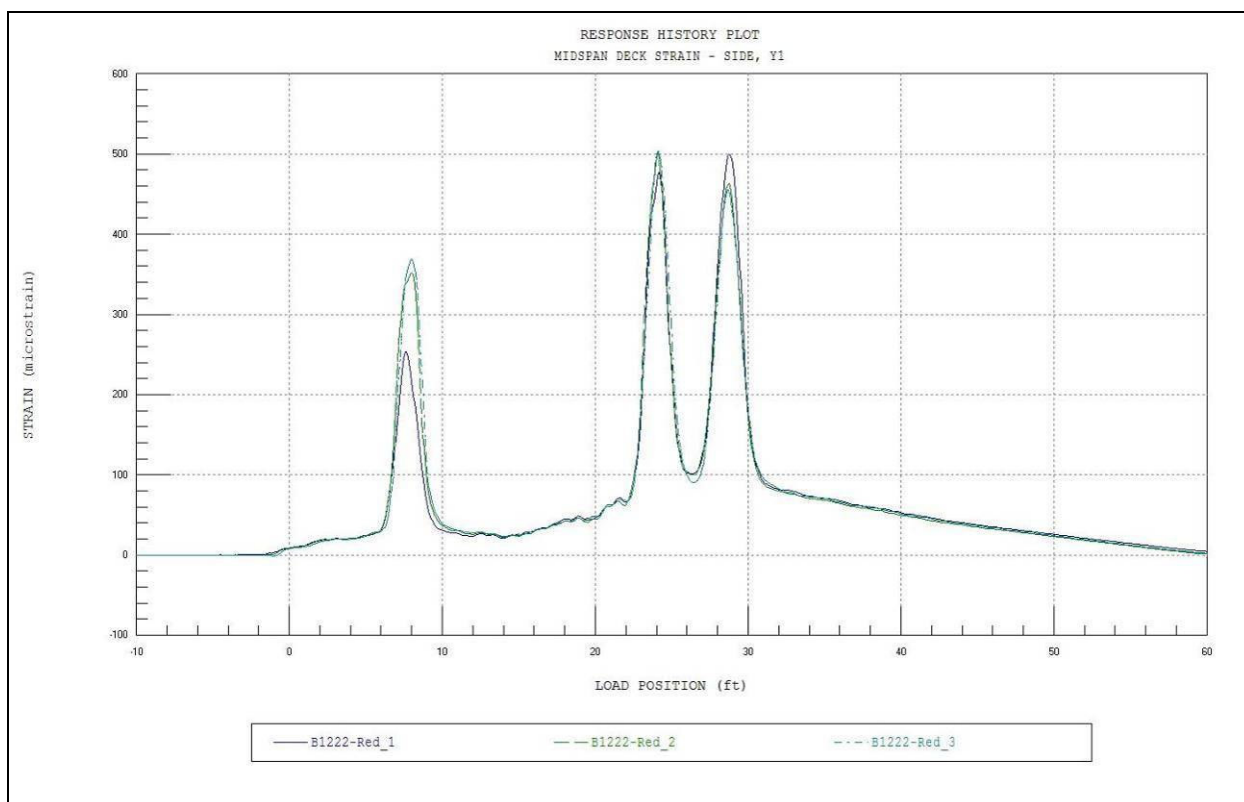
Figure 2.3 Deck strain measurements at exterior bay for 3 truck passes along Path Y1.

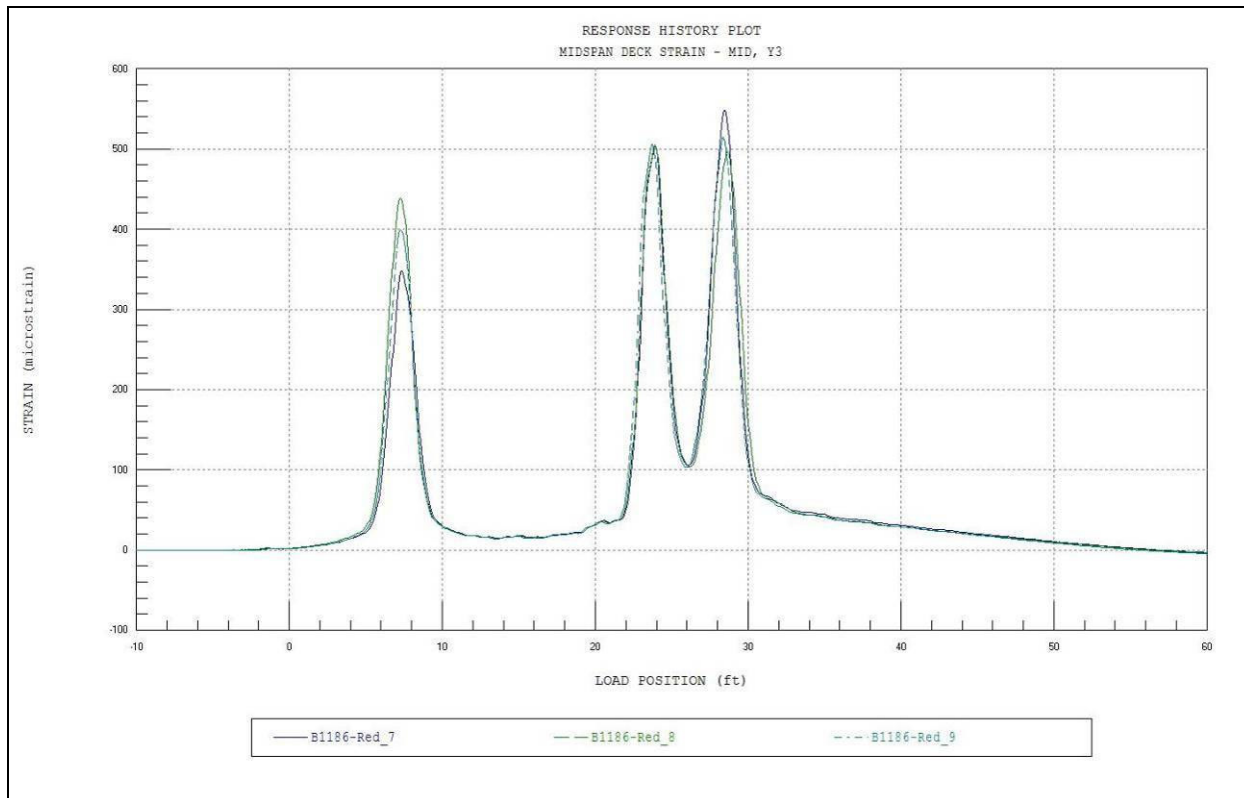
Figure 2.4 Deck strain measurements at interior bay for 3 truck passes along Path Y3.

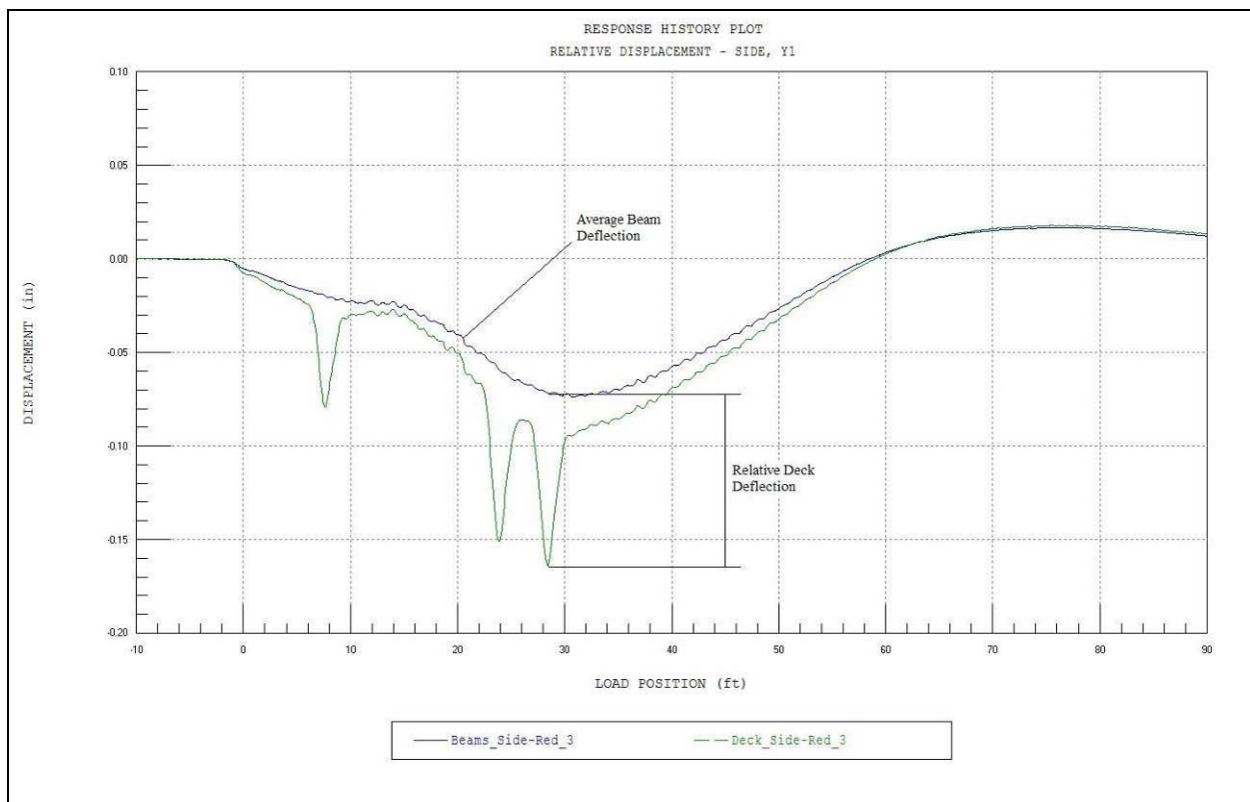
Figure 2.5 Deck deflection and average beam deflection at outer bay for Truck Path Y1.

- ***MIDSPAN FRP DECK DEFLECTIONS:*** Midspan deck deflections were measured at the same locations as the midspan deck strains: in the middle bay directly centered between the two interior beams, and in one side bay directly centered between an interior beam and the corresponding exterior beam. However, in order to isolate the relative deck deflection from the total bridge deflection (deck and beams), beam deflections were also measured. By subtracting the average of the two adjacent beam deflections from the total measured deflection at a given midspan deck location, the relative deflection of the deck itself was obtained. Figure 2.5 through Figure 2.8 shows the maximum total midspan deck deflection and respective average beam deflection for each truck path.

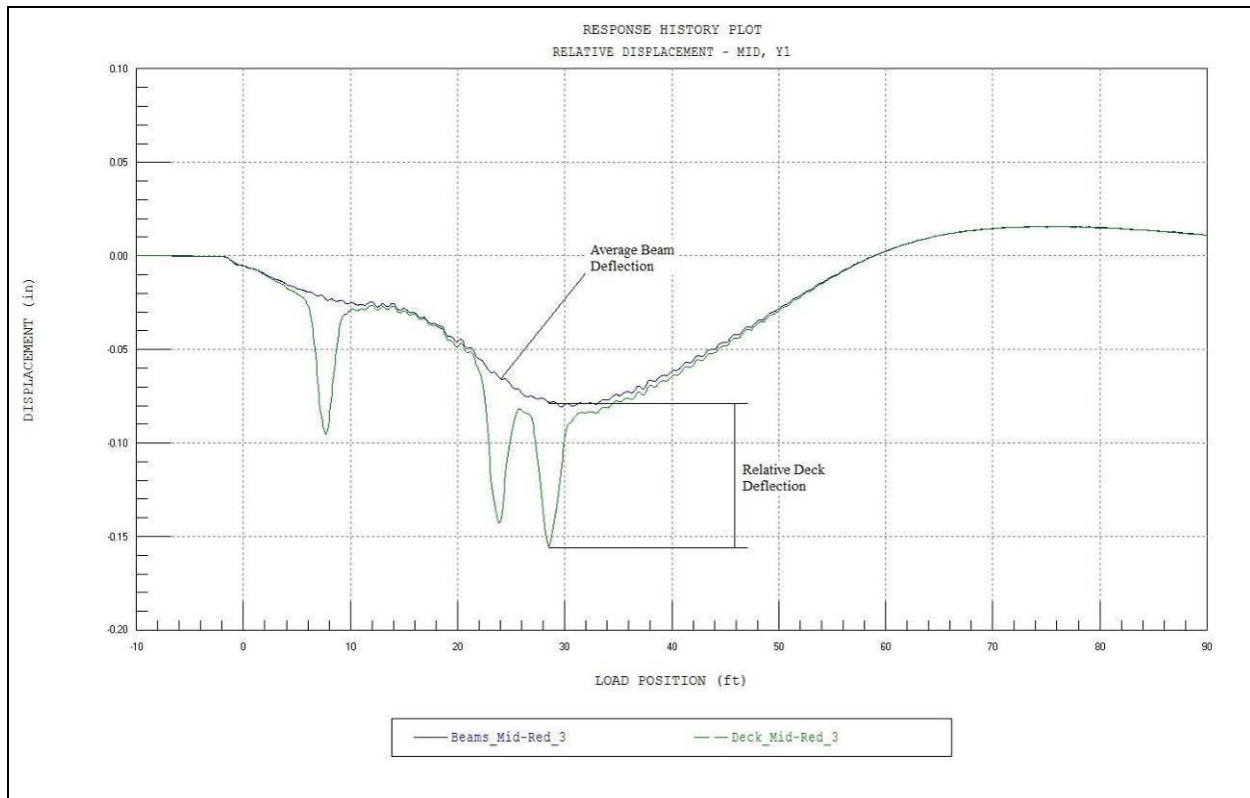
Figure 2.6 Deck deflection and average beam deflection at inner bay for Truck Path Y1.

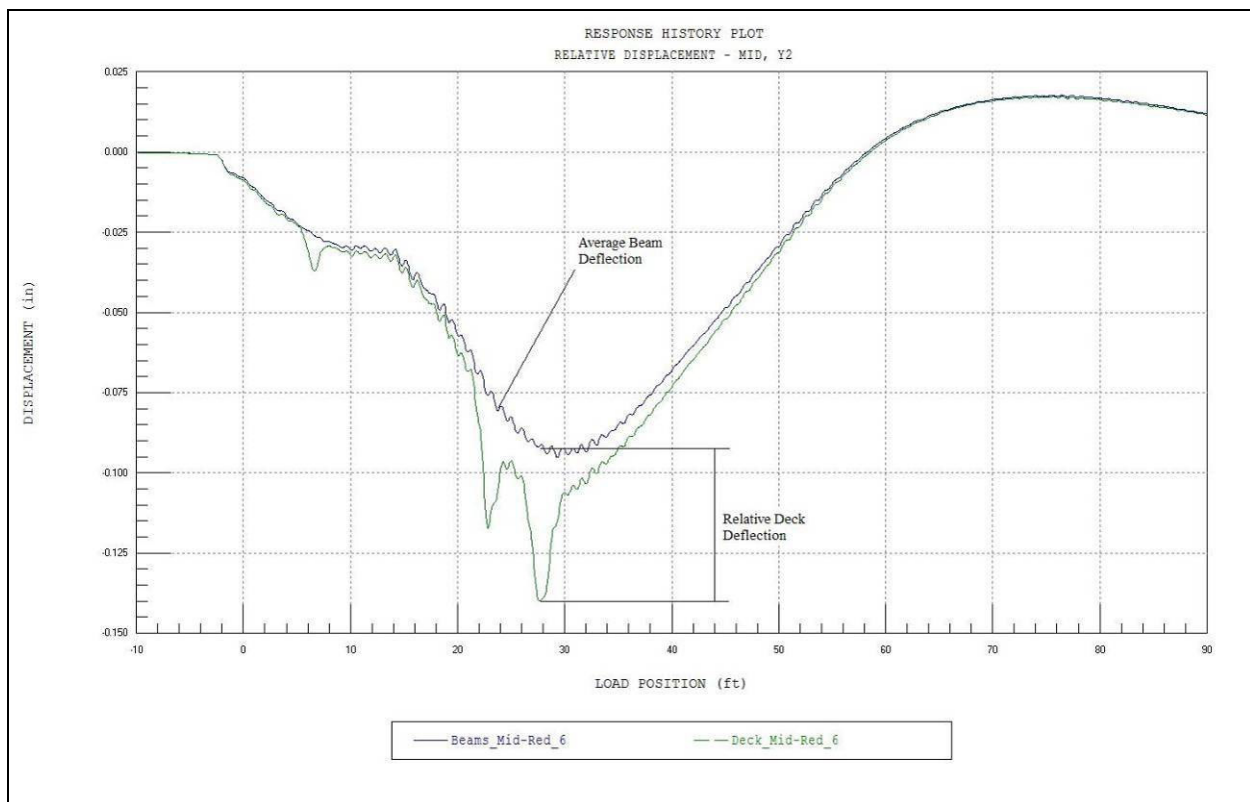
Figure 2.7 Deck deflection and average beam deflection at inner bay for Truck Path Y2.
